SIGAR Inspection 13-5

IMAM SAHIB BORDER POLICE COMPANY
HEADQUARTERS IN KUNDUZ PROVINCE: \$7.3
MILLION FACILITY SITS LARGELY UNUSED

JANUARY
2013

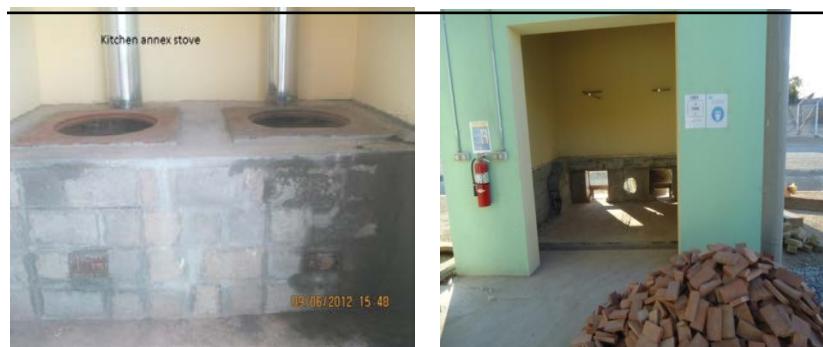
Wood burning stoves installed on September 6, 2012 (left photo), but dismantled (right) by the time of the SIGAR visit on November 19, 2012.

SIGAR recommends that USACE, in coordination with the NATO Training Mission-Afghanistan/Combined Security Transition Command-Afghanistan (NTM-A/CSTC-A), review plans for constructing Afghan police facilities to determine whether site construction contracts can be downsized or facilities redesigned to reduce unnecessary costs or if facilities, including this location, are needed. If this facility is needed and plans are in place for its use, SIGAR recommends reviewing the feasibility of installing backup power or connecting to the local grid, awarding an operation and maintenance contract or providing training to Afghan personnel, and determining why wood-burning stoves at the site were dismantled.

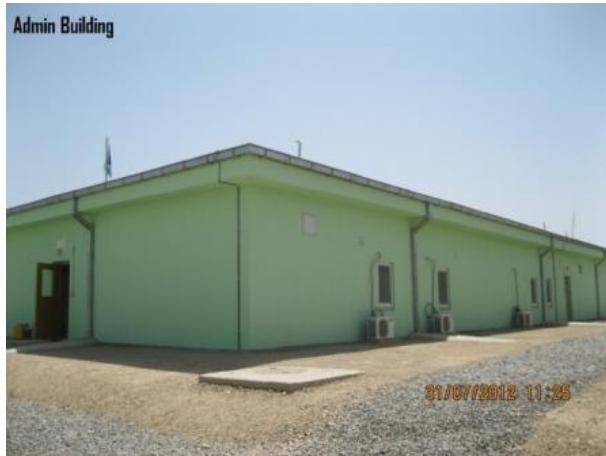
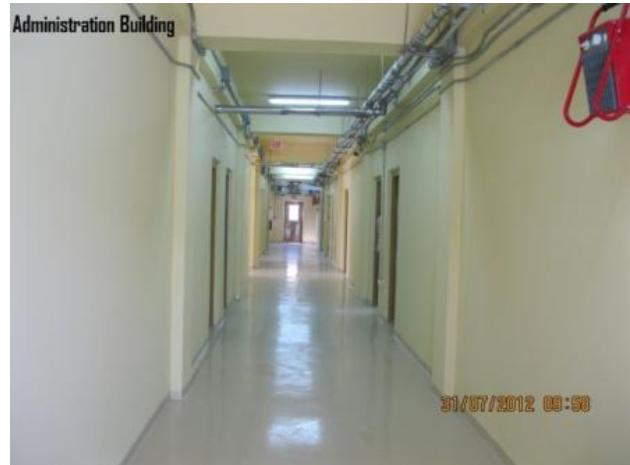
We were able to obtain access to the site's administration building (see figures 3 and 4) and combination latrine/ablution(bathing)/laundry building (see figures 5), as well as to a small building attached to the site's dining facility that was designed to house two wood-burning stoves. This latter facility was connected to the dining facility by a covered walkway and wood storage area. The site, as a whole, was clean and appeared to be well-maintained. Structural construction of the facilities we were able to visit generally appeared to meet contract and design specifications. For example, we found no construction defects in the administration

building or the latrine. In addition, the fueling point for Afghan Border Police vehicles and the on-site electrical generator was observed to be running during our visit (see figure 6). Although we could not access the well house or water tank, the potable water system was functional as evidenced by the availability of water to the toilets and showers.

Figure 3 - Exterior of the Administration Building

Figure 4 - Interior of the Administration Building

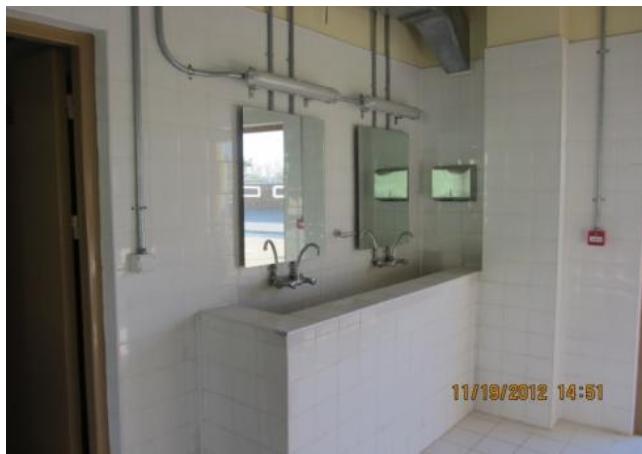
Figure 5 - Sinks in the Combination Latrine, Shower, Ablution, and Laundry Building

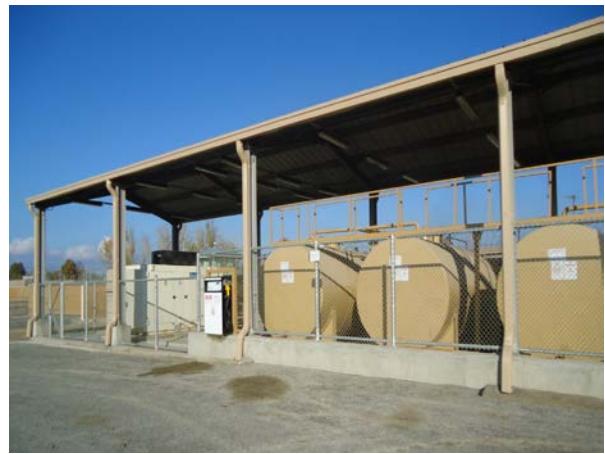
Figure 6 - Combined Fueling Point for Afghan Border Police Vehicles and Site Generator

Our inspection found other use and sustainability issues. For example, the site has no backup generator or connection to the municipal power grid. As a result, electrical power will be unavailable during periods that the on-site generator is undergoing maintenance or repair, when fuel is unavailable, and during periods of unexpected outages. In addition, there is neither an operation and maintenance contract for on-site facilities and equipment nor are there plans to provide training for local Afghan personnel to keep these systems in good working order. The site is fairly new, largely unoccupied, and, to date, has had little need for operation and maintenance support. Nevertheless, sustaining site support facilities—including the electrical generator; fueling station; water treatment system, and the heating, ventilating, and air conditioning systems—will require operation and maintenance skills, especially given the site’s remote location. We recently reported similar findings in our inspection of the Kunduz ANP headquarters facility.¹²

- 2. Rather than relying solely on a single generator, determine the feasibility of installing a backup generator or connecting the site electrical system to the local power grid to prevent loss of electricity across the site when the primary generator is out of service for repair or maintenance or from unintended power outages, including lack of fuel.**

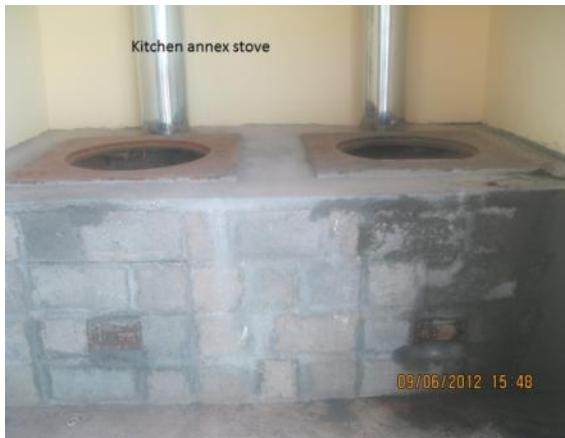
Furthermore, some equipment installed during construction had been dismantled at the time of our site visit. Specifically, two wood-burning stoves had been constructed in a small annex adjacent to a covered walkway that connected the annex with the site's dining facility (see figure 7). At the time of our November 2012 visit, however, the two stoves had been dismantled (see figure 8).

Figure 7 - September 6, 2012, Photograph of Two Installed Wood-Burning Stoves

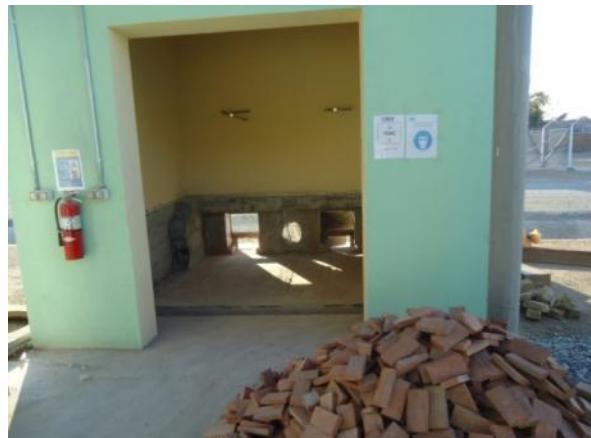
According to the Afghan Border Police commander present during our site visit, the stoves had been dismantled to make minor repairs. In contrast, three other Afghan personnel present on-site told us that the stoves had been removed from the annex so that the building could be used instead for storage. We were unable to resolve the discrepancy between these explanations during our visit. In particular, it is unclear from our observations whether the stoves had ever been used, raising questions as to how it was known that repairs were needed.

Furthermore, if repairs were indeed necessary, the stoves would have still been under warranty and so any minor repairs should have been referred by Afghan officials to USACE-TAN. Specifically, the Federal Acquisition

Figure 8 - November 19, 2012, Photograph of Dismantled Stoves

NTM-A/CSTC-A concurred with Recommendation 4 and took corrective action. An NTM-A/CSTC-A investigation disclosed that the Afghan Border Police had dismantled the wood-burning stoves because the pots they were using were larger than the available cooking area on the stoves provided. The Afghans have built a new larger stove and are currently using it. NTM-A/CSTC-A will incorporate this lesson learned into future construction standards.

- 4. Determine why the Afghan Border Police dismantled the wood-burning stoves at the Imam Sahib Border Police Company Headquarters and assess the need to provide wood-burning stoves at other facilities currently under construction or planned for the future.**
